Assessment of Drainage Structure by Using ArcGIS Software: The Case of Bale Robe Town, Ethiopia

Gutema Wakjira, Garuma Negasa. Assessment of Drainage Structure by Using ArcGIS Software: The Case of Bale Robe Town, Ethiopia. *Journal of Civil, Construction and Environmental Engineering*. Vol. 6, No. 5, 2021, pp. 149-160. doi: 10.11648/j.jccee.20210605.14

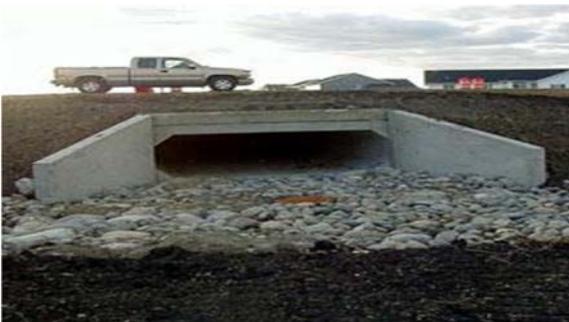
Culvert is a closed conduit for passage of runoff from one open channel to another. One example is a corrugated metal pipe under a roadway. Subsurface drainage systems drain water that has infiltrated through the pavement and the inner slope but also groundwater. Subsurface drainage systems are directly linked to surface drainage systems [10]. According to the SRA handbook, culverts are road constructions with a theoretical span of 2.0 m. Culverts or subsurface drainage system have an open inlet and outlet and conduct water underneath a road. Particular care in both design and maintenance is required to prevent obstruction of water flow by obstacles [13].

Figure 3. Culverts source [13].

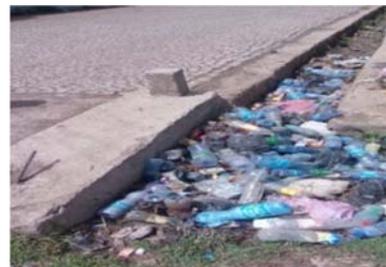
In Bale Robe Town, as stated above in Figure 9 of this document, about 69 percent of the existing drainage structure is open drainage structure. There is also no garbage or gunge nears the roads. So, the road users and the surrounding society are using this existing drainage structure as garbage. Therefore, the existing open drainage structures were blocked by dry waste including very small waste like plastic to some large crap like dead animals. Construction materials were also deposited in drainage structures.

Figure 11. Deposited wastes in the drainage structure.

vegetation that growth in drainage structure, properly cleaning of drainage structure before and after rain, early maintenance of drainage structure based on the severity of defects.

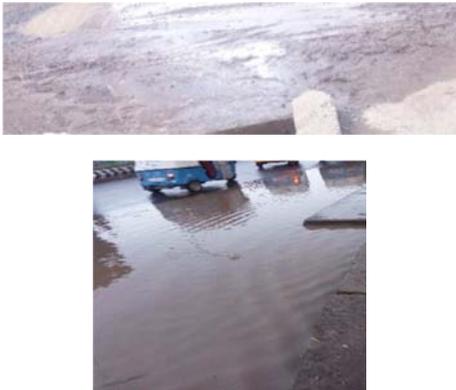
The carriage ways of the highway and side drainage structures were not properly connected. The drains, the structure which remove water from carriage way to side drainage, were clogged by sediments and other wastes. So, water from carriage way do not enter in to the drains instead it flows on carriage ways of the highway.

Figure 13. Improper connection of carriage way and side drainage structure.
